VEHICULAR CRASH TESTS OF
THE CALIFORNIA ST-20 BRIDGE RAIL
FINAL REPORT # FHWA/CA/SD/2004/01

**VEHICULAR CRASH TESTS OF
THE CALIFORNIA ST-20 BRIDGE RAIL**

FINAL REPORT # FHWA/CA/SD/2004/01

CALTRANS STUDY # 680323

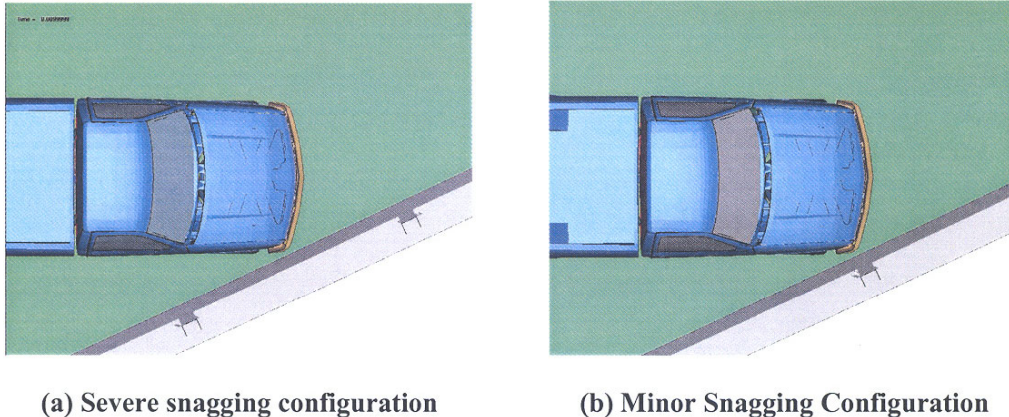
Figure 1. Impact conditions analyzed for the California ST-20 Bridge Rail Design.

The main objective of these preliminary simulations was to assess the likelihood and severity of hood snag on a rail post. The two impact points were selected to have two different impact conditions on the rail. The conditions selected were for a severe snagging potential as shown in Figure 1(a), and for minor snagging potential shown in Figure 1(b). Case (a) results in a large hood overlap over the third rail from the bottom at the time of hood-to-post impact. Both simulations are for a truck front bumper height of 447 mm.

Results from impact case (a) are shown in Figure 2 and Figure 3. Here the hood did snag and was pushed back through the windshield. This behavior indicates that the hood snag has a high potential of contributing to undesirable cab deformations and vehicle motions.
